## Russian Candy Factory Floor is Rehabilitated Using DuraQuartz, P4C & ENECLAD FPS.

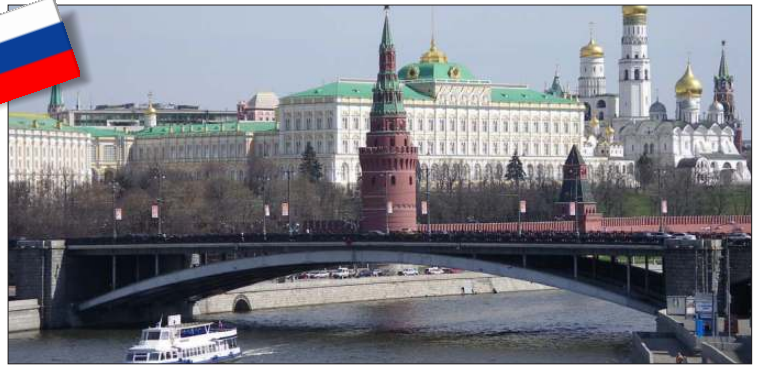
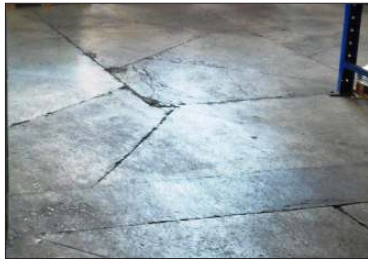
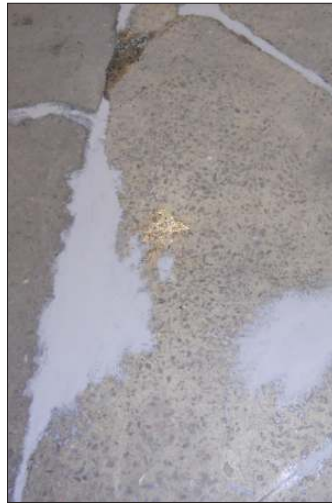
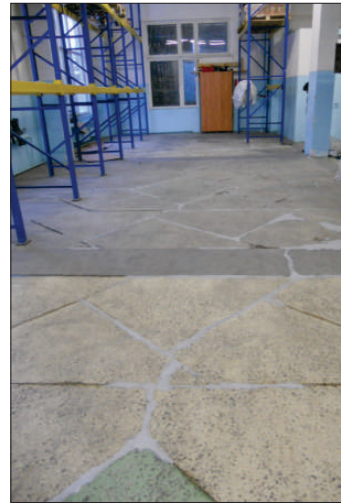
**Problem:** Concrete floor was severely cracked creating a safety hazard and potential damage to finished goods.

**Solution:** The floor was manually prepared and all loose material was removed. ENECRETE DuraQuartz was used to repair all cracks and voids. The floor was primed using CHEMCLAD P4C. Two coats of ENECLAD FPS were then applied. The client was delighted with the results.
